GALION BAY DAM
(LAKE RENE)
NDI I.D. NO: PA-747
DER I.D. NO: 17-107

PHASE I INSPECTION REPORT
NATIONAL DAM INSPECTION PROGRAM

BY
D'APPOLONIA CONSULTING ENGINEERS
10 DUFF ROAD
PITTSBURGH, PA. 15235
JUNE 1979

GALION BAY DAM
NDI I.D. NO. PA-747
APRIL 3, 1979

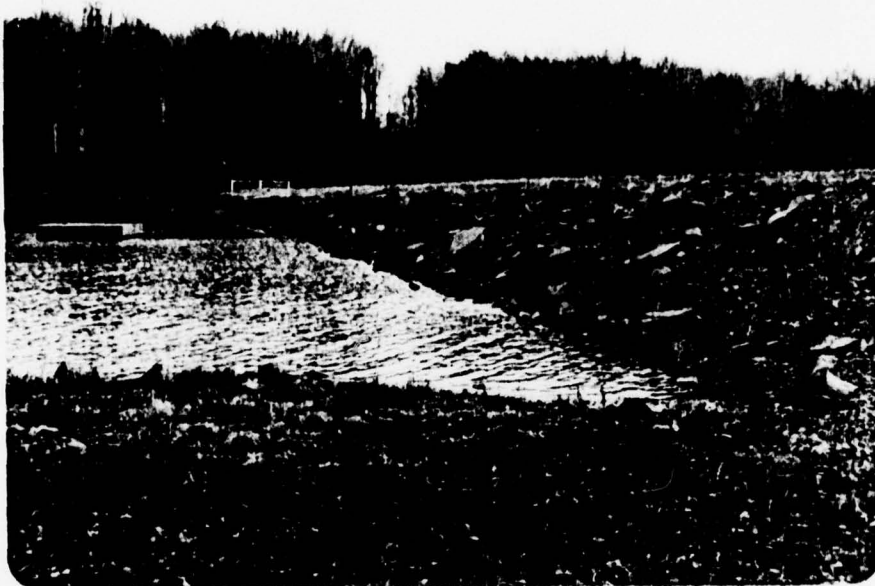
Upstream Face

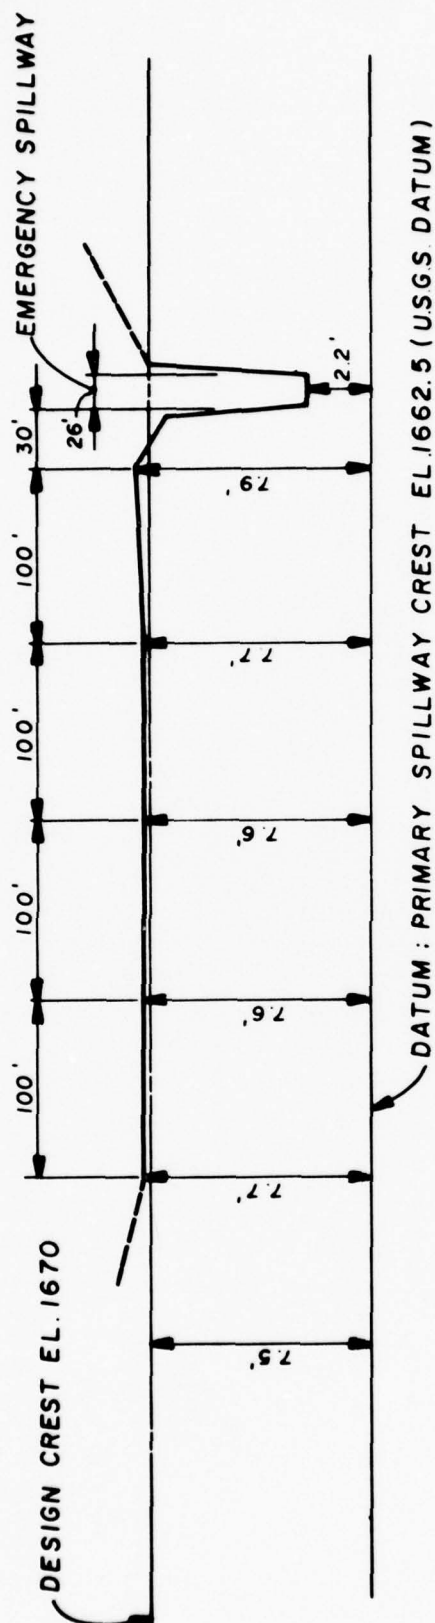
DAM CREST PROFILE
(LOOKING DOWNSTREAM)

The top of the embankment was surveyed relative to the pool level on the date of inspection, which was estimated at Elevation 1662.6 and the lowest area on the crest of the embankment was found to be within 0.1 foot above the design elevation of 1670. The dam crest profile is illustrated on Plate 9.

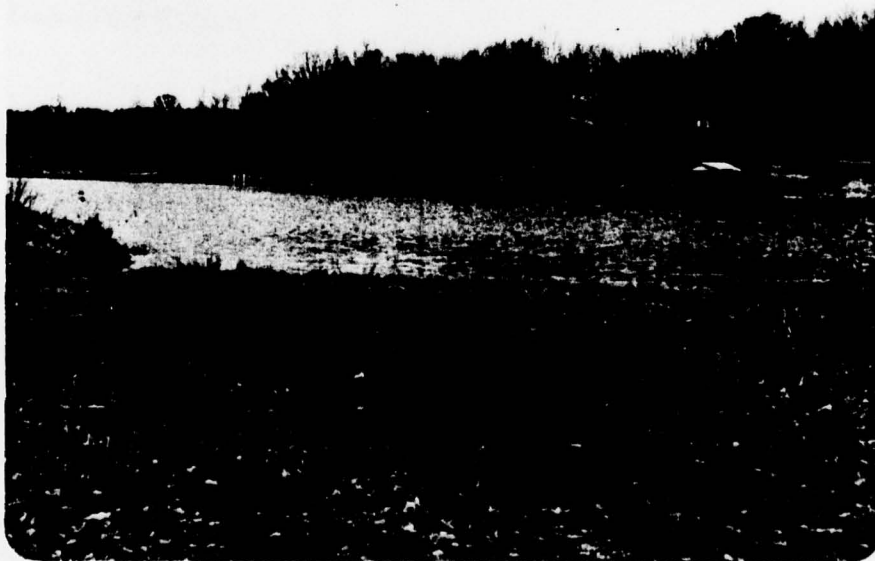
Photograph No. 2

Emergency spillway approach channel.

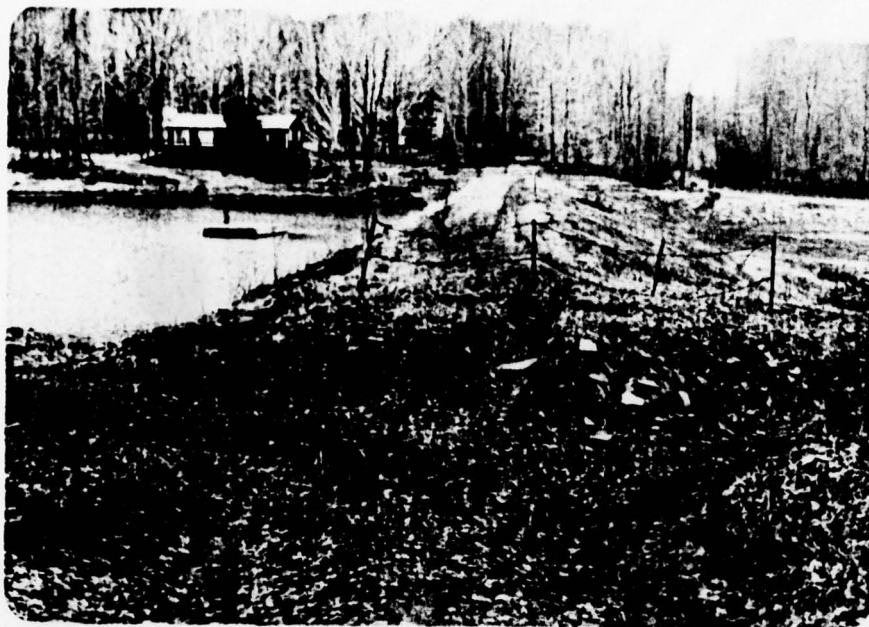
Photograph No. 3

(2) Appurtenant Structures. Lack of adequate riprap on the embankment (left) side of the emergency spillway discharge channel raises some concern as to the potential for erosion of the embankment during large flows through the emergency spillway. Therefore, installation of additional erosion protection on the embankment side of the emergency spillway discharge channel is recommended.

The swampy area observed at the toe area near the left abutment is not considered to be serious relative to the overall performance of the dam at this time. However, this area should be periodically observed to determine if the conditions are changing. A lack of adequate erosion protection on the embankment side of the emergency spillway discharge channel raises some concern as to the potential for erosion of the embankment during large flows through the emergency spillway. Therefore, adequate erosion protection should be provided.

Inadequate riprap in emergency spillway against the embankment.

1. Adequate erosion protection should be provided on the embankment (left) side of the emergency spillway discharge channel to protect the embankment from eroding during flows through the emergency spillway.
2. Around-the-clock surveillance should be provided during unusually heavy runoff and a formal warning system should be developed to alert downstream residents in the event of emergencies.
3. The dam and appurtenant structures should be inspected regularly and necessary maintenance should be performed.

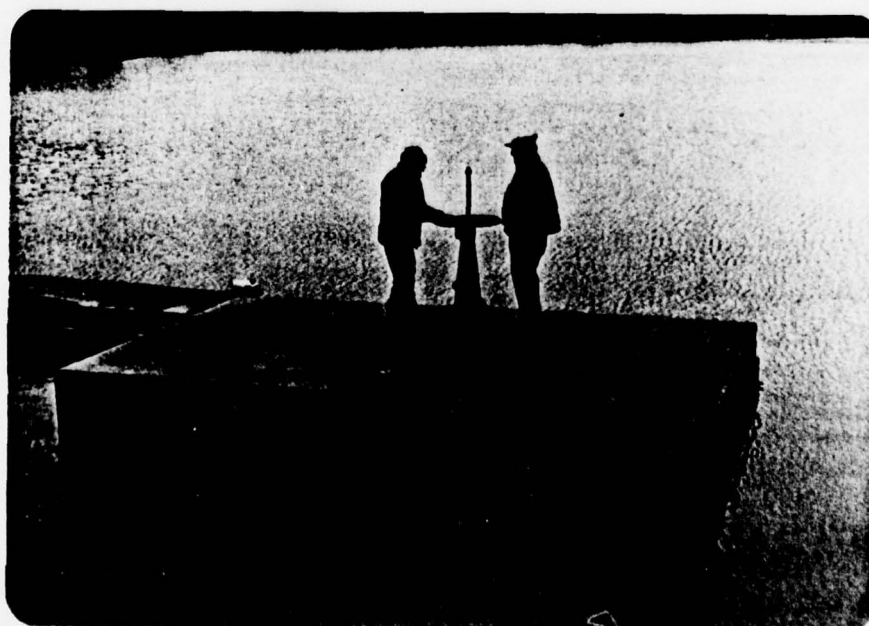
Photograph No. 4

4.3 Maintenance of Operating Facilities. The only operational feature of the dam is the reservoir outlet sluice gate which is operated by a hoist located on the drop inlet structure. The reservoir outlet pipe sluice gate was operated and observed to be functional.

Primary spillway intake structure and outlet pipe sluice gate control.
